# Picus Sonic Tomograph Test Report

## Beecroft Village shops carpark

Hornsby Shire Council, PO Box 37, Hornsby NSW 1630

February 2023

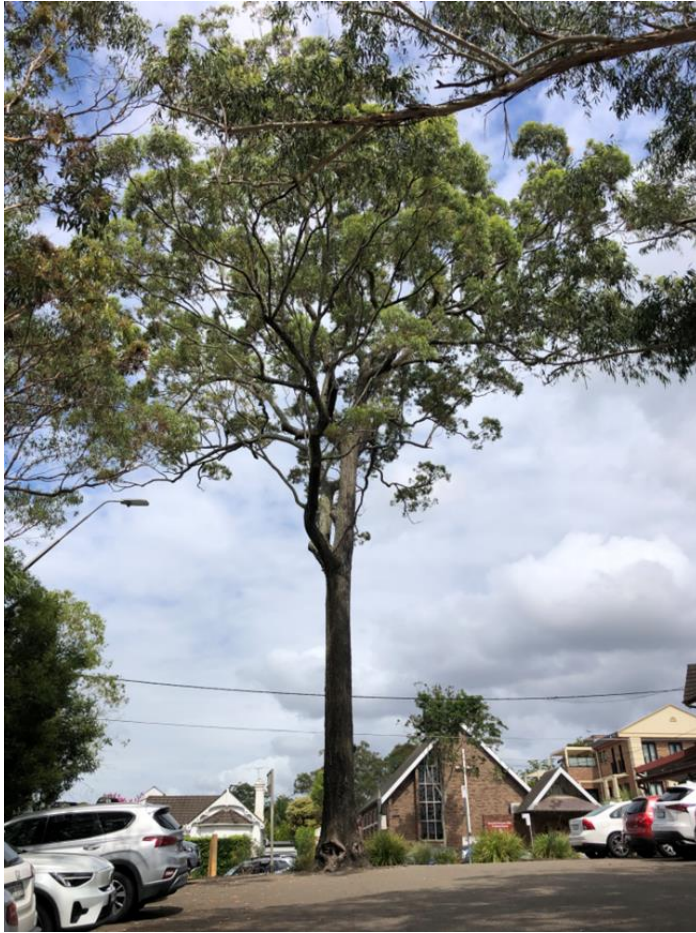
**Plate 1:** The subject tree, Narrow-leaved Ironbark (*Eucalyptus crebra*).  
*P. Vezgoff.*

The subject tree is located in a public car park associated with the Beecroft Village shops. The tree is one of two (2) large mature specimens growing within the car park area, within a cut out of asphalt. Although no fruit could be found, or flowers seen, the tree appears to be a Narrow-leaved Ironbark (*Eucalyptus crebra*). The tree is approximately nineteen (19) metres in height with a symmetrical spread of fifteen (15) metres. There is no deadwood greater than 20-30mm diameter within the canopy. There is a wound between sensors 9-11 and another smaller wound slightly above sensors 12 and 1. The wounding appears to have been happening over a number of years causing extensive cambial dieback. Wound wood is developing, however a decay pathogen has established within the wound as evidenced by the large fruiting body that is approximately one hundred and forty (140) millimetres wide between sensors 7 and 8. Another fruiting body is located on the south side of the trunk at approximately eleven (11) metres from ground level near a first order limb (Plate 3).

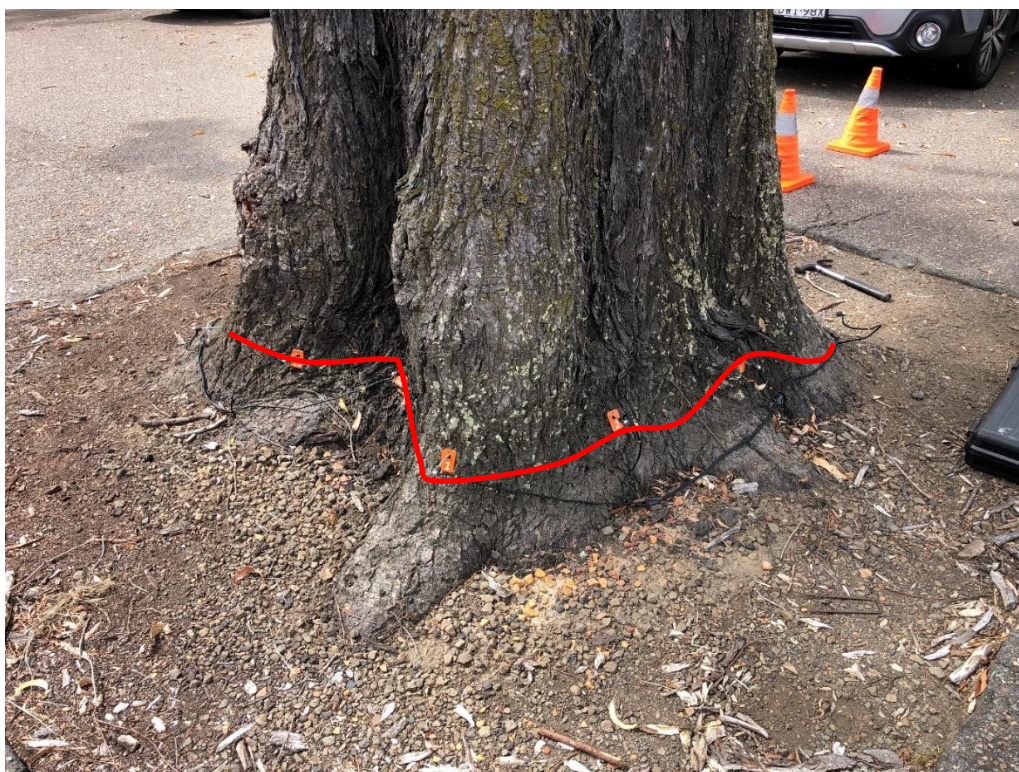
One (1) ultrasound test has been conducted on this tree. Test 1 was conducted at one hundred (100) millimetres from ground level (Plate 3 and 4). The test was undertaken to assess the structural integrity of the base of the tree due to the presence of the wound and fruiting body.

*Plate 3: North side of test area. Red line is the approximate location of the test. P. Vezgoff.*

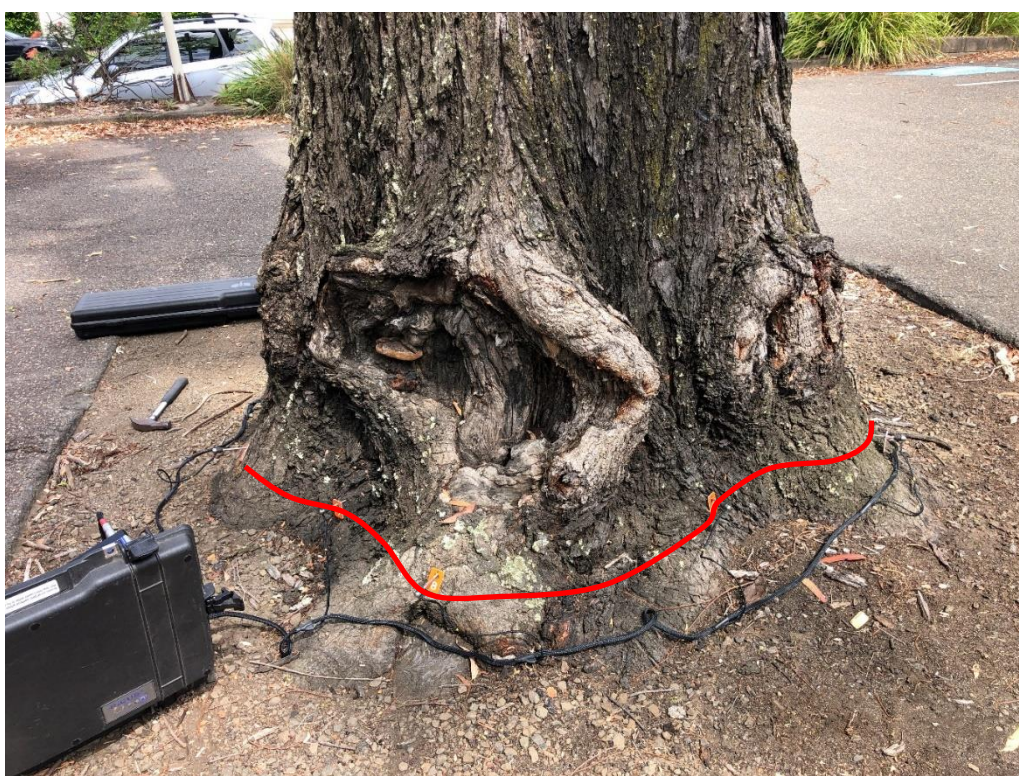
*Plate 4: South side of test area. Red line is the approximate location of the test. P. Vezgoff.*

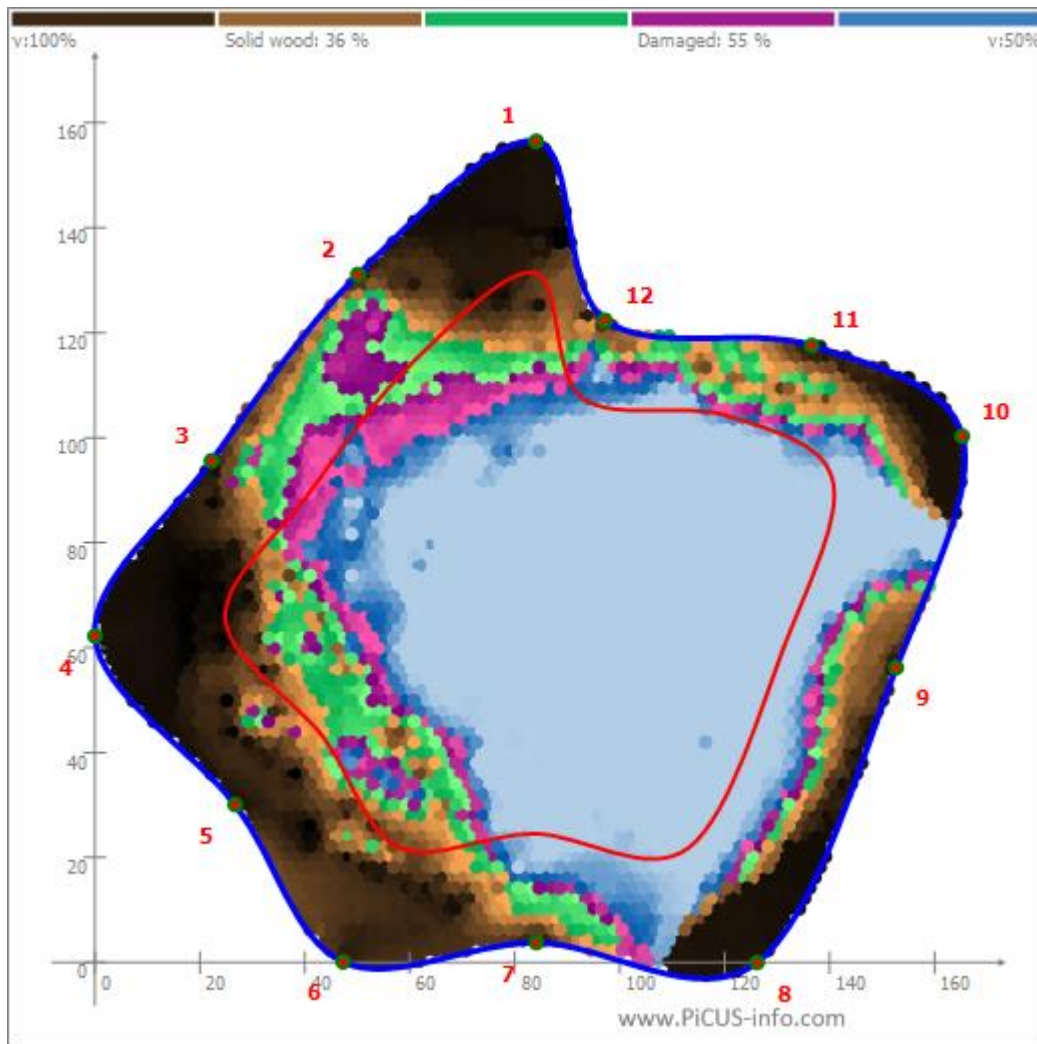
The test results show that the tree has 36% sound wood at the test location and 55% is showing as damaged wood (Plate 5).

**Plate 5:** Tomogram of the test location. Sensor 1 is north. The red line is indicative of the 70/30 ratio taken as a radial measurement from the centre of the trunk to each sensor. The area of damaged wood has reached the t/R limit of the red line.

The subject tree is becoming structurally compromised at the base. It is unlikely an area of decay this large will compartmentalize completely due to the extent of decay involved. Due to the decay being within the basal area it is also possible that the roots of this tree have been affected by the decay fungi. Due to the element of risk that this tree could fail at the root plate or main stem, I have recommended this tree be removed.
