arboricultural impact assessment report

AIA-01

Revision B, Issued for REF
17 March 2023

Hornsby Park / Hornsby Quarry – Embellishment Works

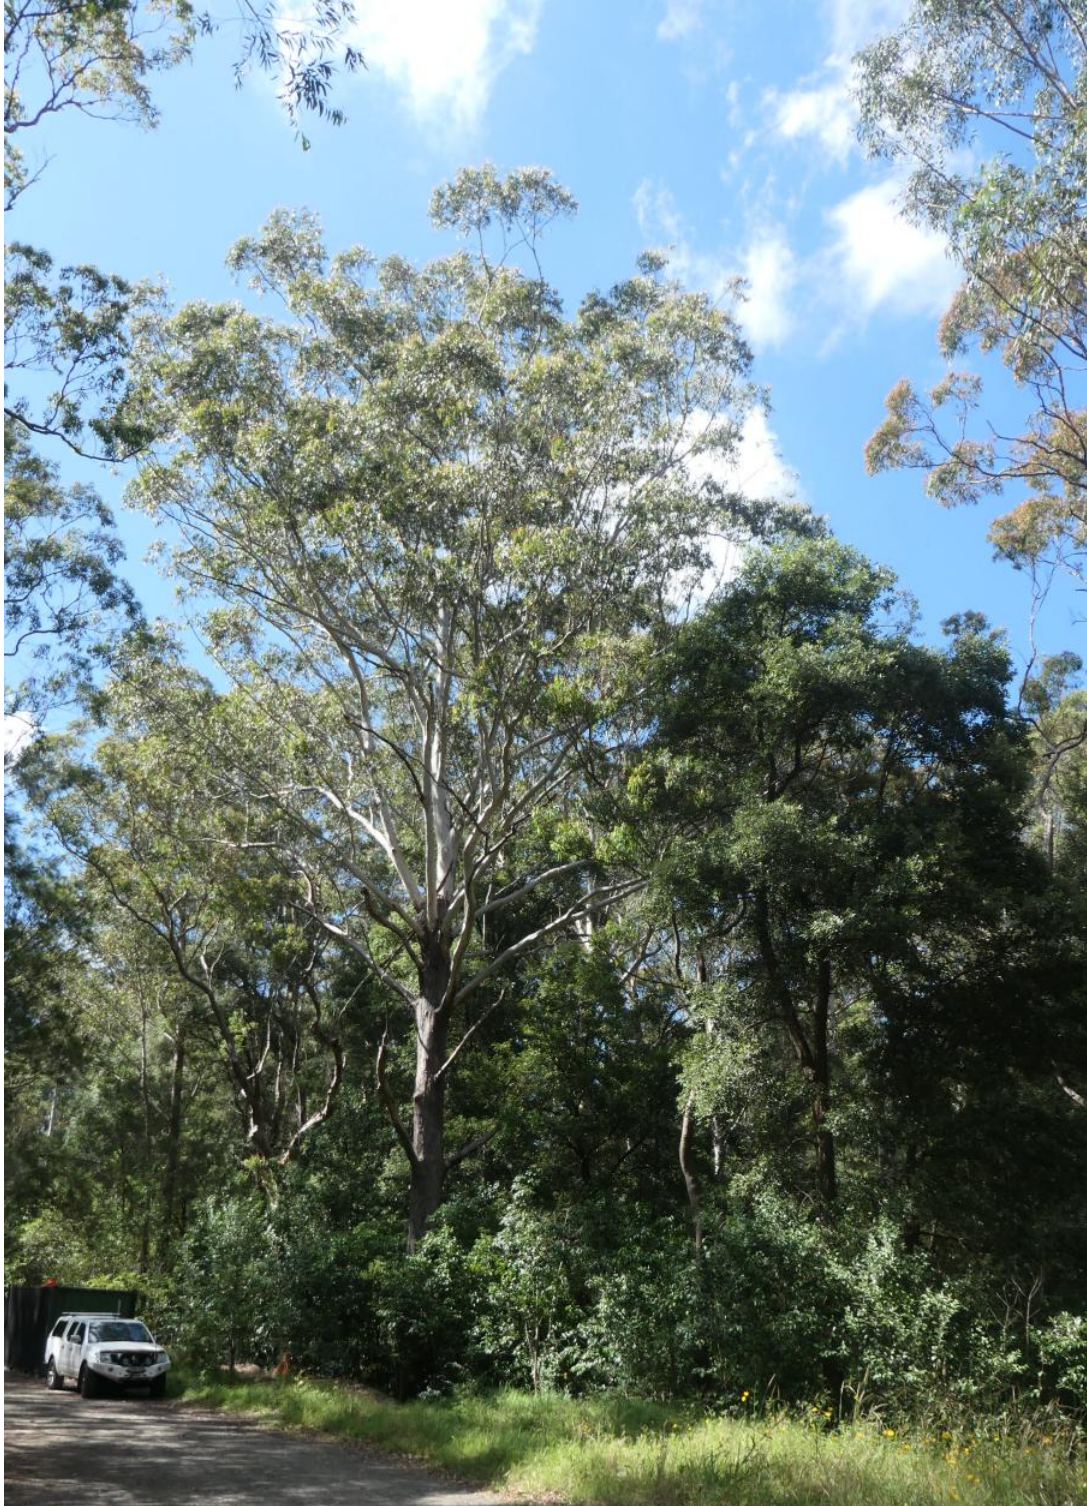
Figure 16 – The site contains numerous significant and impressive endemic trees such as this Blackbutt (*Euc. pilularis*) which often stand well in excess of 30m tall and with trunk diameters close to 1m at ground level. These older trees often provide significant habitat with numerous small hollows and spouts that would support native wildlife. (Photo: Arterra 25 November 2022)

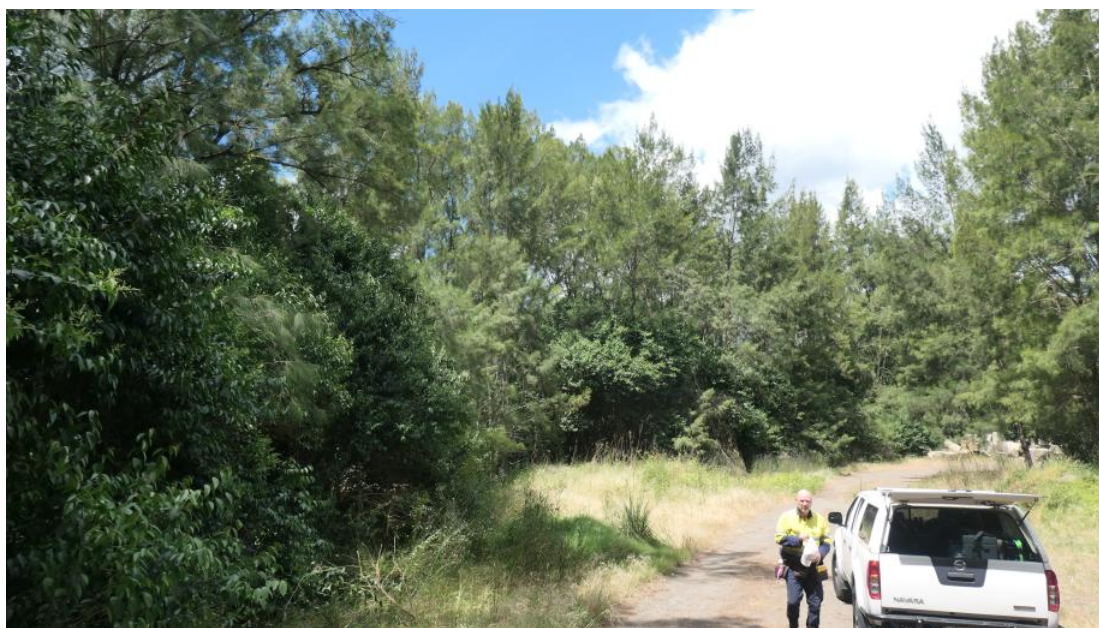
Figure 19 – Introduced *Casuarina* dominated Planting around the Crusher Plan. (Source: Arterra 2/12/22)

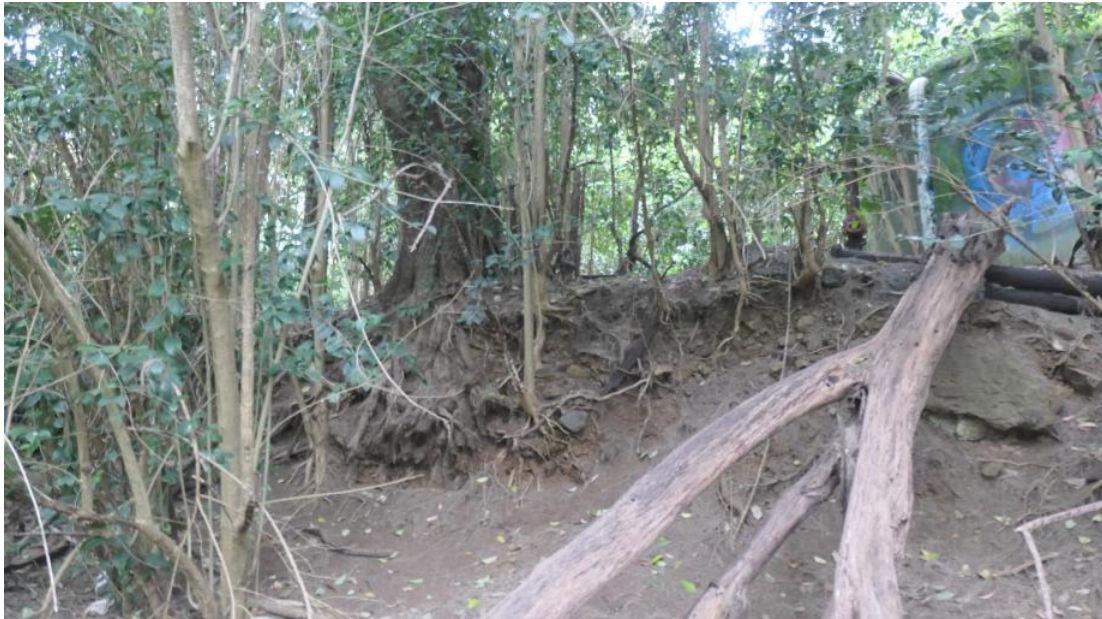
Figure 21 – Photo illustrating tree root development in extreme environments such as on edges of steep embankments may be very atypical and not confirm to normal circular and nominal TPZs. Once the exact nature of proposed earthworks and disturbances are known it may be necessary to undertake more detailed and site specific analysis of individual trees that are desired to be retained and protected. (Photo: Arterra 2/12/22)

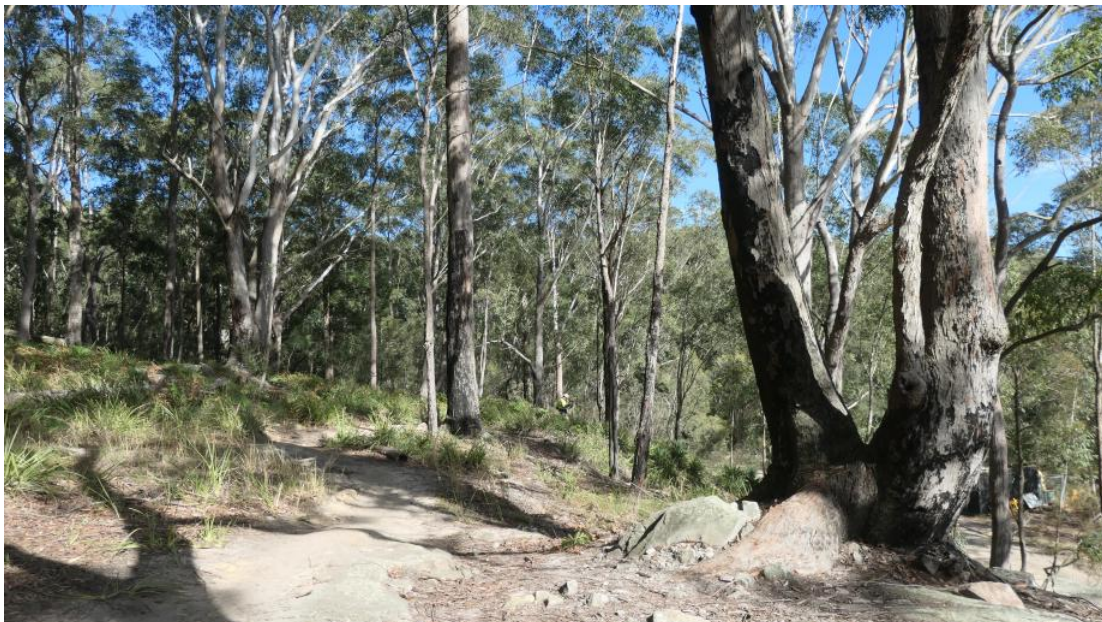
Figure 22 – Photo illustrating tree root development in extreme environments such as steep embankments and rock influenced environments where roots may be very atypical and not conform to normal circular and nominal TPZs. More detailed and site specific analysis of individual trees that are desired to be retained and protected may still be needed during detailed design resolution. (Photo: Arterra 2/12/22)
