arboricultural impact assessment report

AIA-01

Revision B, Issued for REF
17 March 2023

Hornsby Park / Hornsby Quarry – Embellishment Works

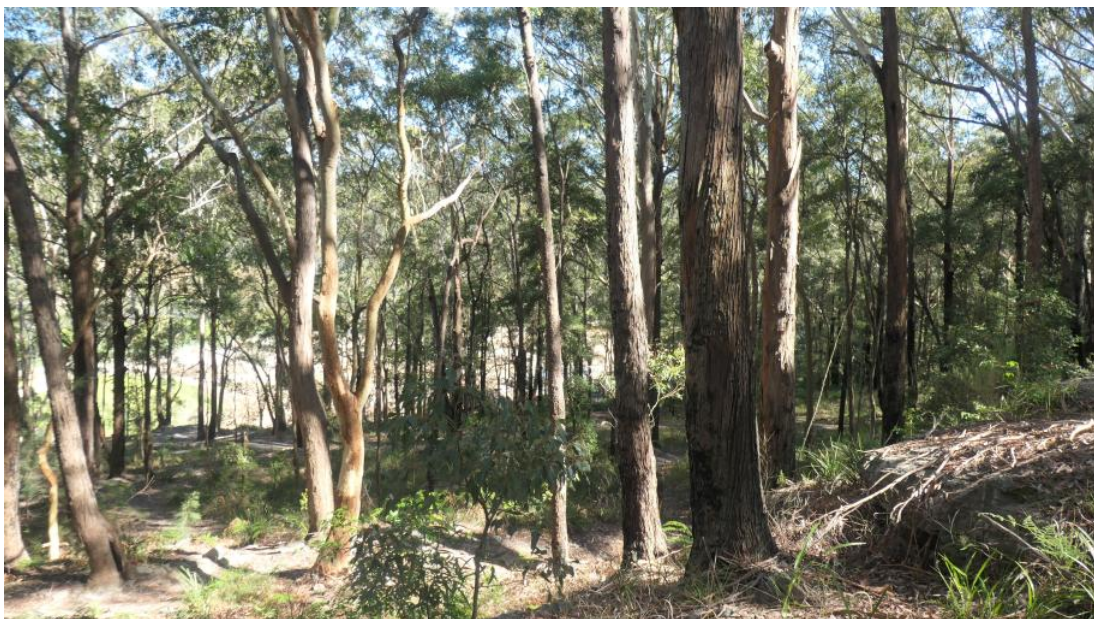
Figure 17 – Blackbutt and Angophora dominated forest below the Hornsby Pool. (Source: Arterra 24/11/22)

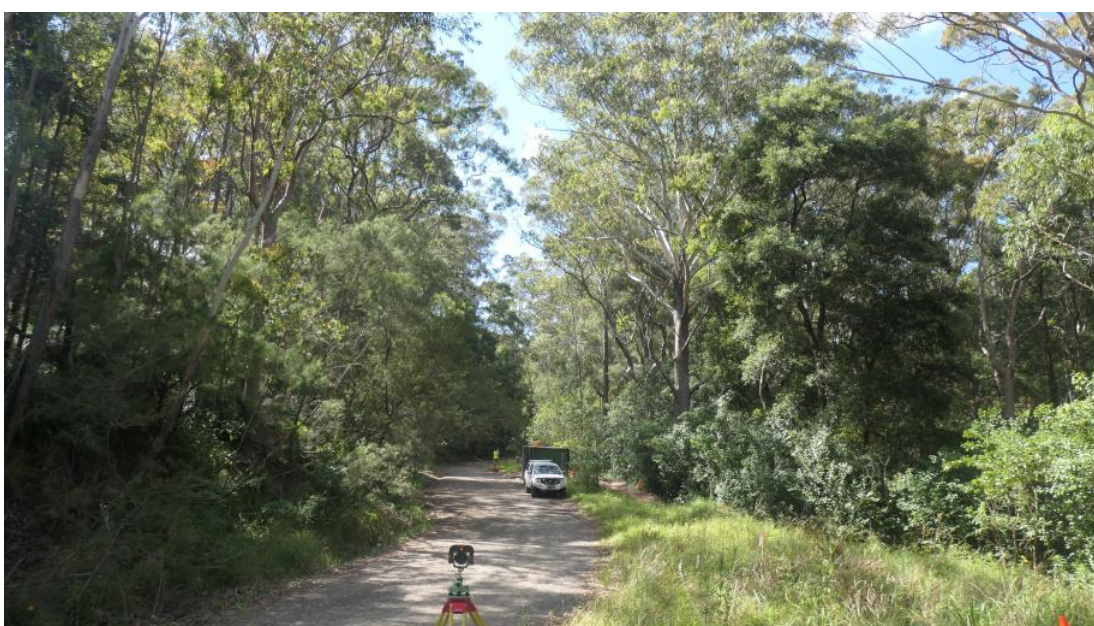
Figure 18 – Blackbutt and Angophora dominated forest along the fire trail off Quarry Rd leading to OMV. (Source: Arterra 25/11/22)
